Reinstalling Flame Rod in Sideline Elite Fireplace

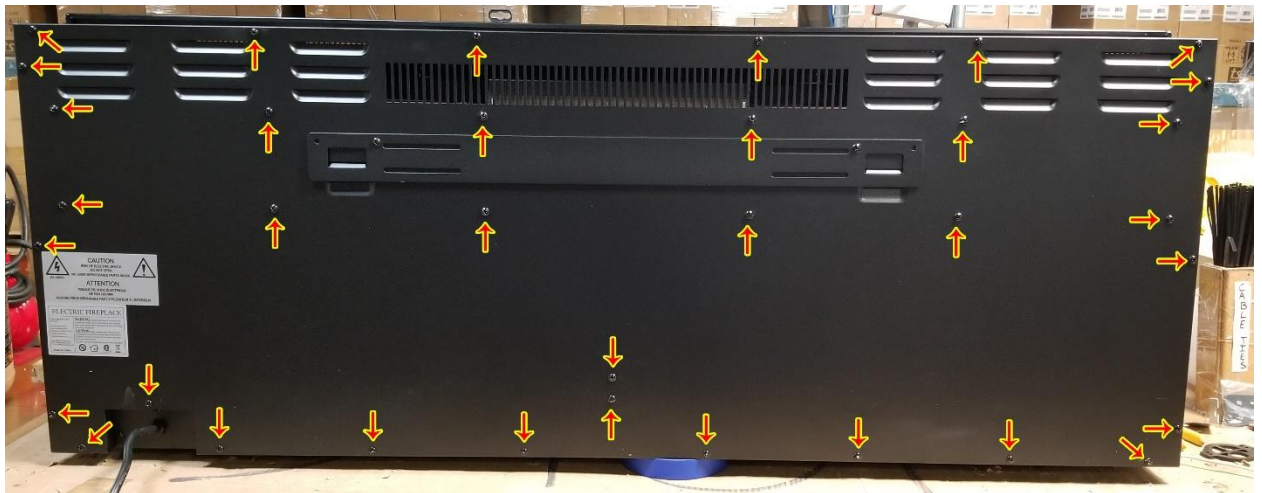
1. Turn Off Sideline Elite Fireplace.
2. Remove the glass panel from fireplace and remove the fireplace from the wall. Check the user manual for instructions on removing the front glass panel and removing the unit from the wall.
3. Once removed from the wall, remove the screws shown below from the back of the fireplace.

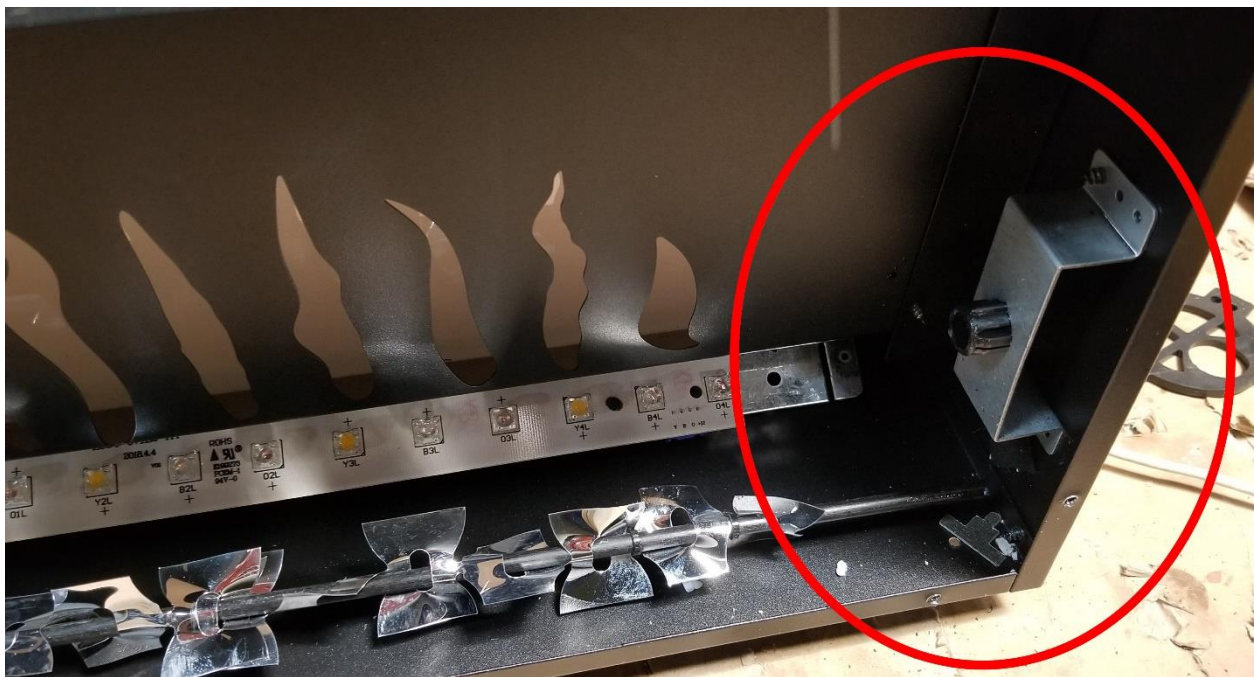
4. Once the back panel is removed, you will have access to the flame rod. If the flame rod is out of it's socket, it will look like the picture below.

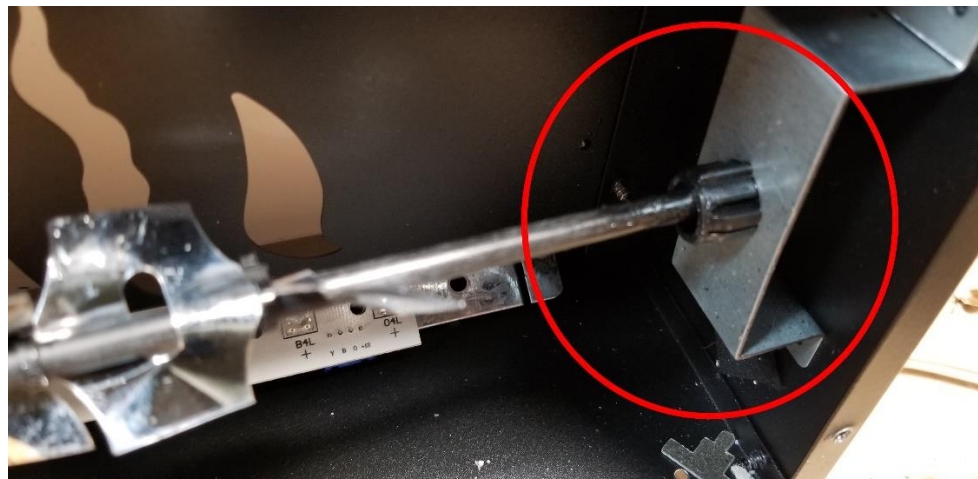
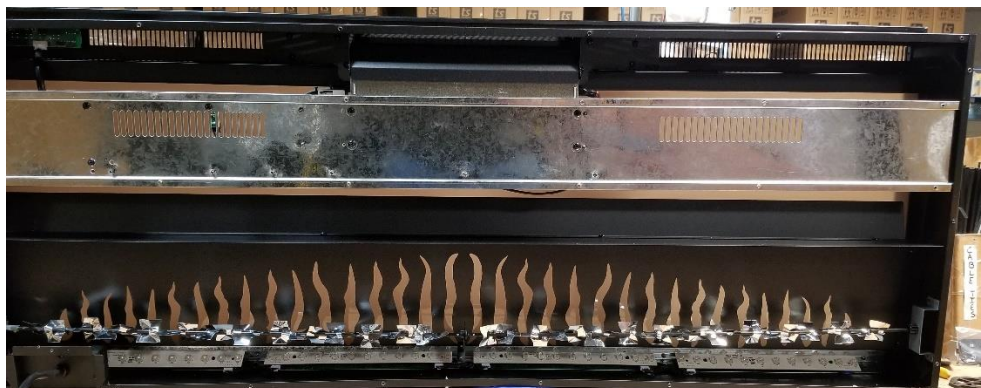
5. Re-insert the flame rod back into the socket.

6. Once the flame rod is inserted back into the socket, test the fireplace. You should no longer hear the rattling noise.

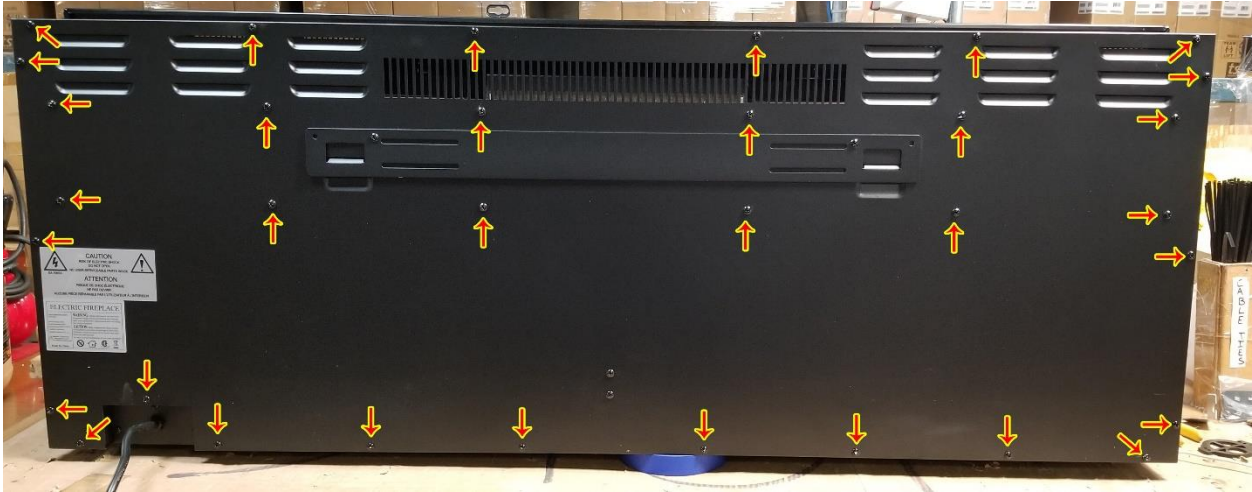
8. Once the flame rod holder is attached, reinstall the remaining screws for the back panel.
