Reinstalling Flame Rod in Sideline Elite Fireplace

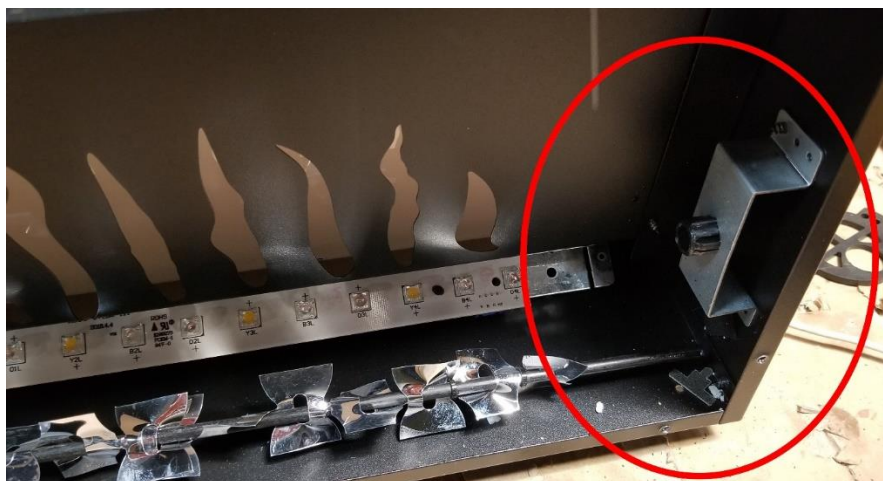
7. After removing the flame panel, locate the end of the flame rod that is out of its socket.

**Please note, as you are opening the unit from the front, the flame rod socket will be on the left side when looking at the unit. The pictures below show the back panel of the fireplace removed.
