## Removing Flame Rod Bracket in Sideline Elite Fireplace

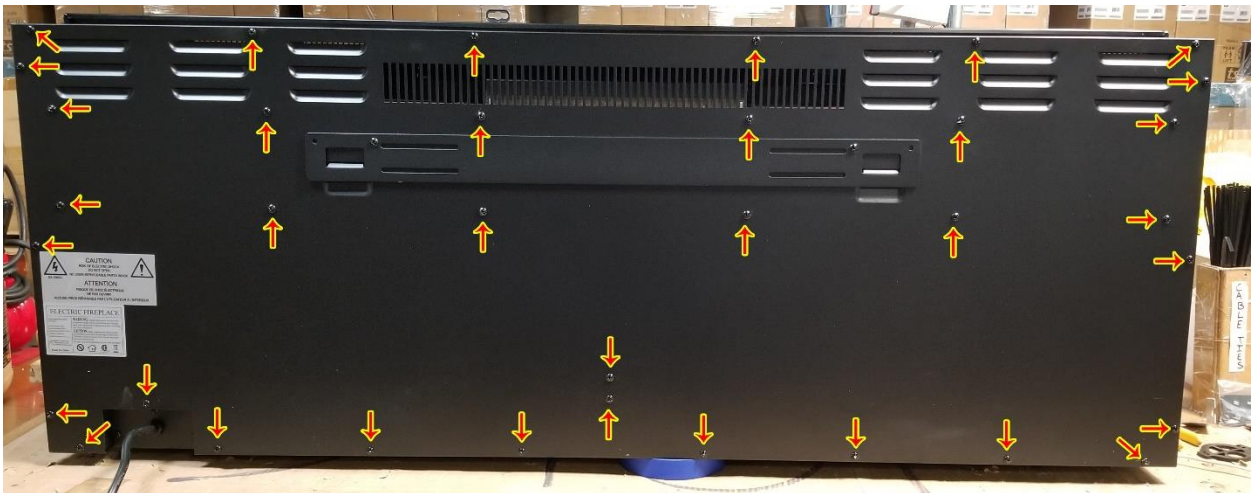
1. Turn Off Sideline Elite Fireplace.
2. Remove the glass panel from fireplace and remove the fireplace from the wall. Check the user manual for instructions on removing the front glass panel and removing the unit from the wall.
3. Once removed from the wall, remove the screws shown below from the back of the fireplace.

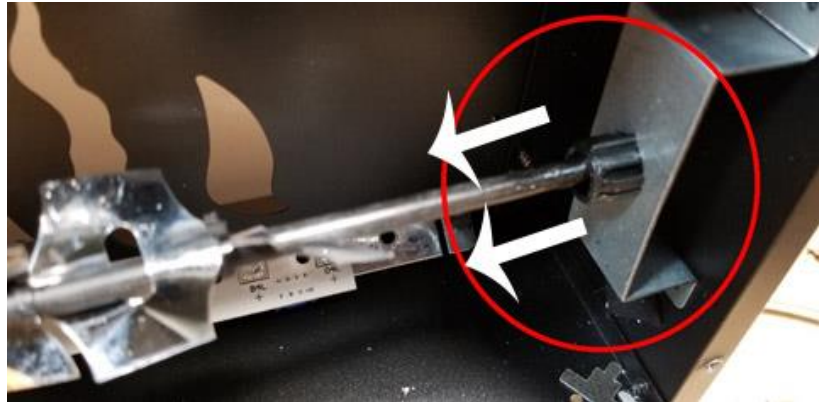
5. To relubricate, pull the flame rod out of the grommet.

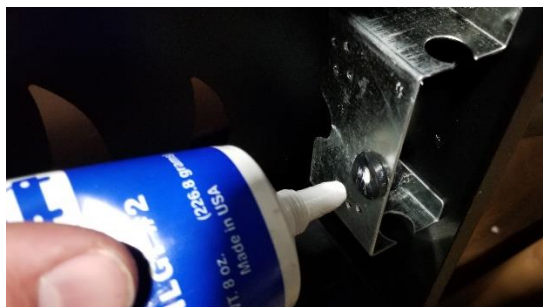
6. Once the flame rod is removed from the grommet, place lubrication in the hole in the grommet.

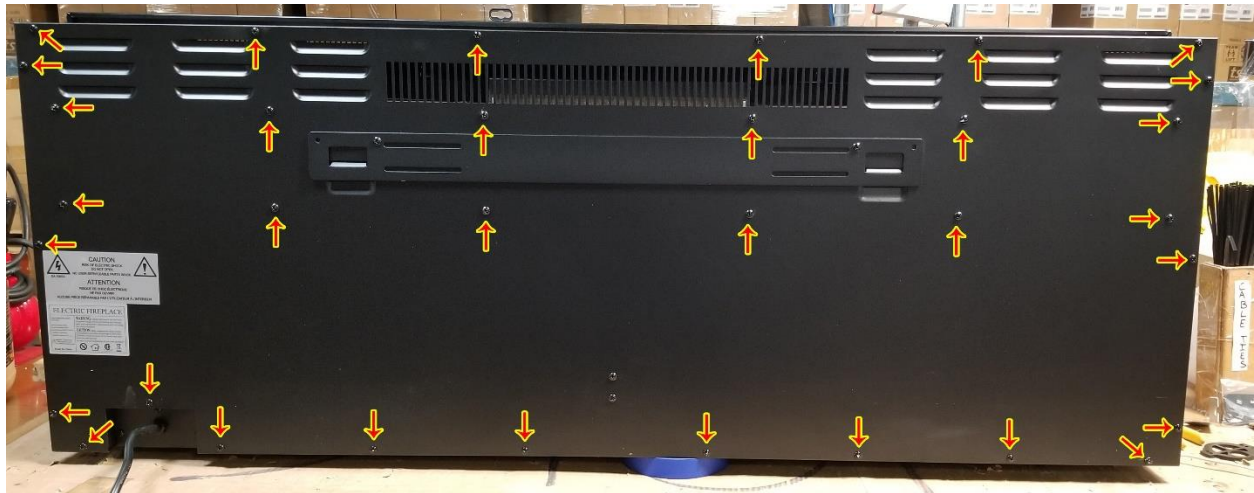
8. Once completed, reinstall the backpanel on the fireplace by securing the back panel screws shown below.
